Immediate Removal of an Entrapped Central Venous Catheter Guide Wire

Key words: Central venous line – Guide wire entrapment – Venous angle – Thoracic surgery

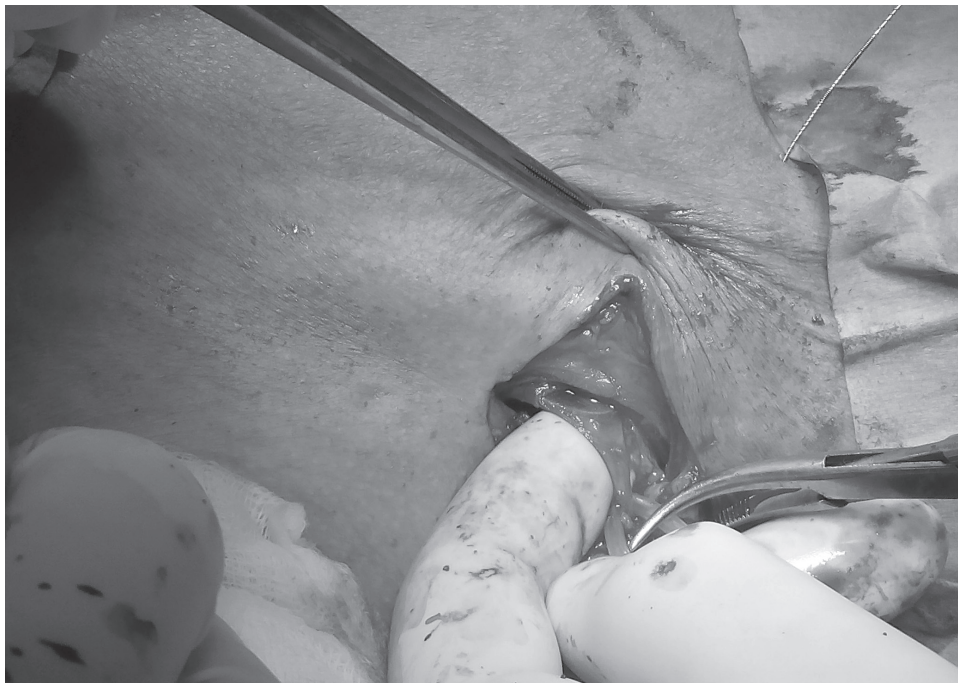
Figure 1 – The external jugular vein was freed, and a plastic tube used as a tourniquet.

Subsequently, standard disinfection was performed and barrier protection ensured. The part of the guide wire protruding from the skin was shortened. After skin incision, the platysma muscle was dissected allowing access to the subclavian triangle and reach the venous angle. At that point, an arc of the guide wire could be seen through the venous angle wall. The external jugular vein was freed, and a plastic tube used as a tourniquet (Figure 1). Venotomy of the external jugular vein was performed and the central (i.e. distal) part of the guide wire was smoothly withdrawn via the venotomy. The kinking of the guide wire was clearly visible (Figure 2). The guide wire was then clipped off just proximally to the kinking. Next, the remaining part of the wire (i.e. the medial part) was extracted via the same venotomy site, when the frayed area of the medial part of the guide wire was also clearly identified.

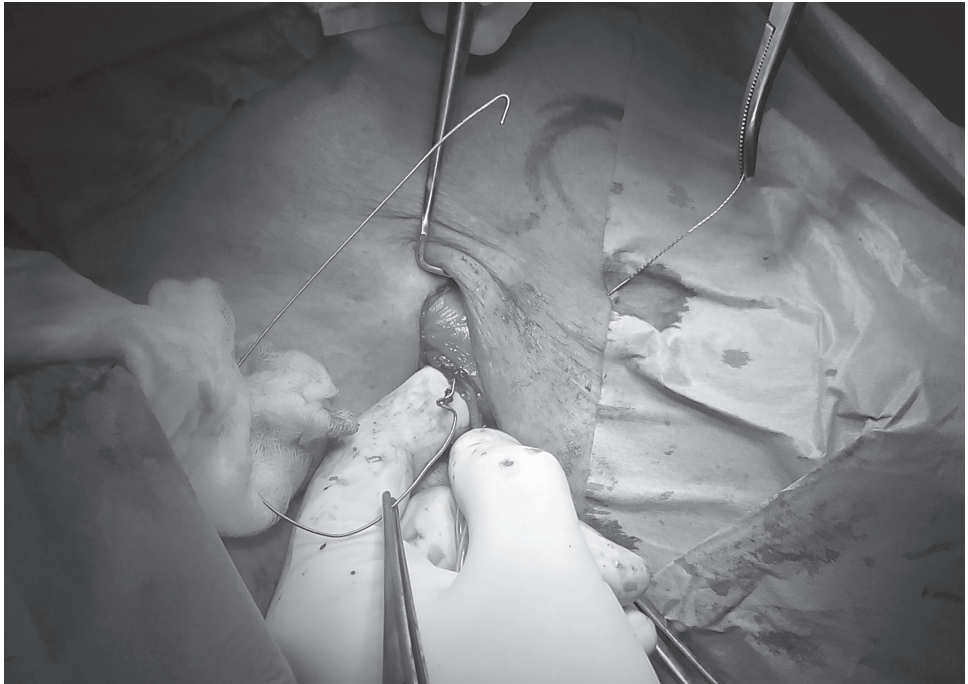
Manoeuvring with the patient's shoulder and arm also failed to unblock the guide wire. When, subsequently, more force was applied, it seemed the guide wire would be easily extracted. However, after a few centimetres, the guide wire failed to move anymore and, when carefully inspected, its body seemed to be elongated and the spiral part partially separated from the inner one. By palpation in the supraclavicular area, in the subclavian triangle, it was possible to feel a cranially oriented concave loop or bend of the wire at a site corresponding anatomically to the venous angle. A movement of the soft tissue at the guide wire introduction site below the clavicle, slightly lateral to the medioclavicular line, was evident when traction to the wire was applied. The patient's history did not suggest any known anatomic variations of the respective part of the venous system or the upper thoracic outlet that could be possibly attributed to the guide wire entrapment. There were no changes on the ECG (electrocardiogram).

Figure 2 – The kinking of the guide wire was clearly visible.

The guide wire (now in three parts) was inspected and found to have been completely removed. The venotomy site was closed; no vascular lesion occurred in the meantime. The wound was closed and the primary procedure (open right-side lung decortication) was then performed without further complications. It was decided not to place another central venous line, but to opt for two large-bore peripheral catheters.
